Saint Switch Test Report TR-1082
Revision A

Structural Integrity and Performance of RL9-K005 REALLOCK_{TM}

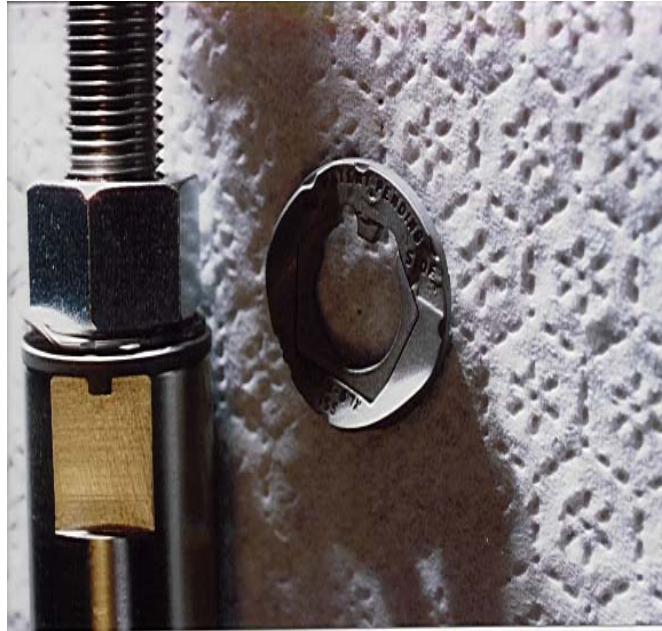
The test setup is illustrated in the photographs at the end of this report.

- 1 - insert REALLOCK_{TM} on the slotted and threaded shaft
- 2 - insert the shaft in the internally threaded cylinder a minimum of 5 turns
- 3 - line up the REALLOCK_{TM} key with the slot in the cylinder
- 4 - turn the nut finger tight into the REALLOCK_{TM}
- 5 - apply torque to the test value. Record using a torque wrench
- 6 - remove nut and REALLOCK_{TM}
- 7 - observe condition and record findings
